Greening the grey:
improving the biodiversity
value of sea wall flood
defence embankments

**Dr Tim Gardiner, Biodiversity Officer
Environment Agency**

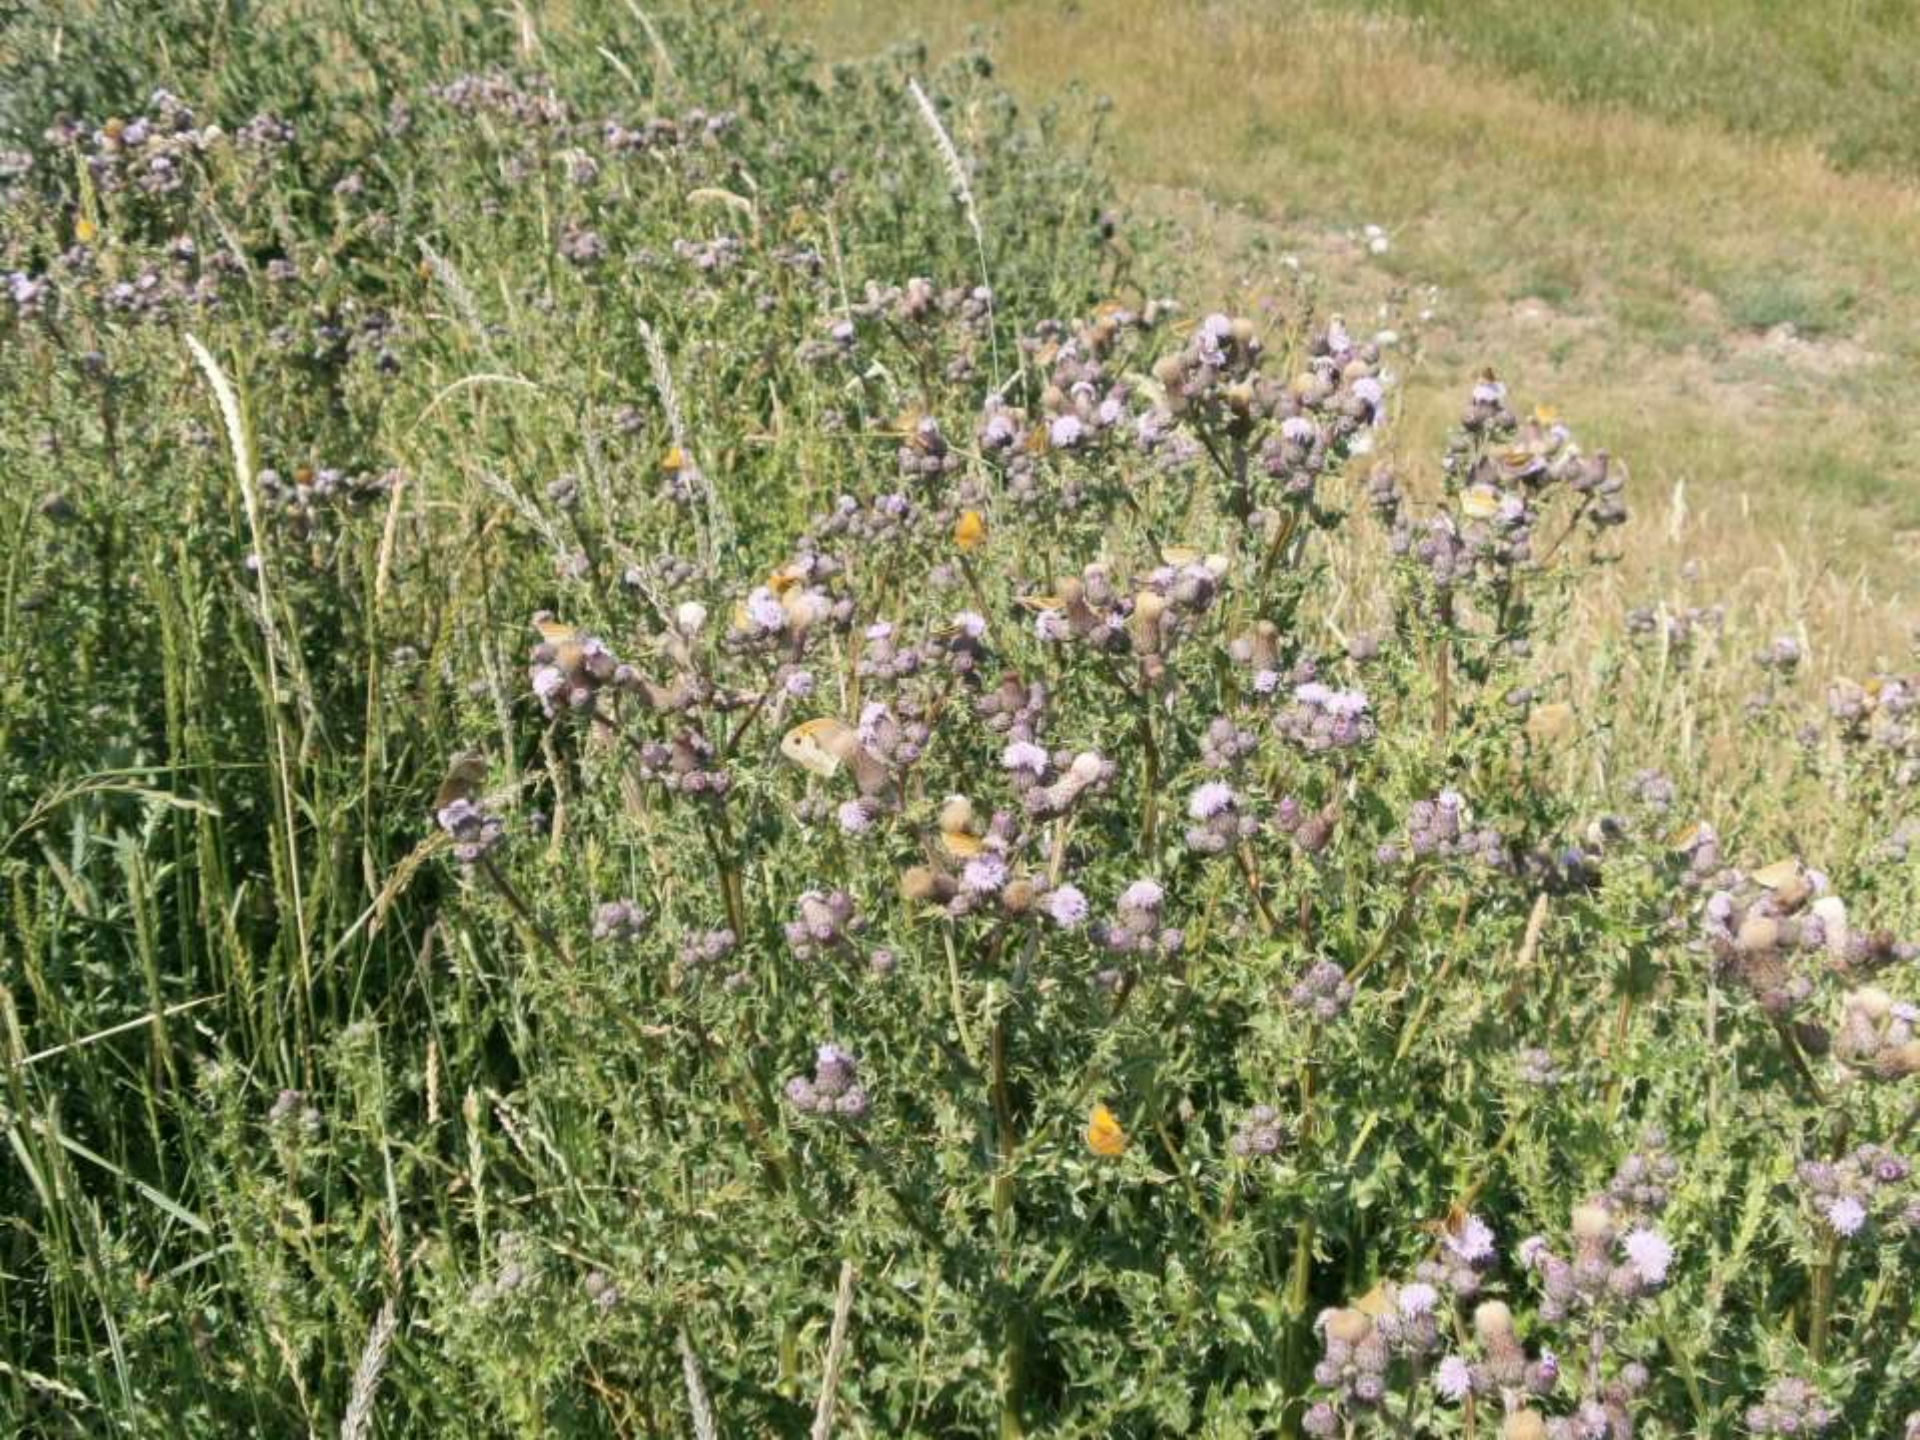
A photograph showing a close-up of a dry, cracked, brownish soil surface on the left, transitioning into a dense patch of Sea Barley grass on the right. The grass has thin, green blades and numerous upright, feathery seed heads that are a mix of light brown and purple. The text "Vehicle ruts" and "an important habitat" is overlaid in large, bold, black font at the top.

**Vehicle ruts
an important habitat**

Sea Barley

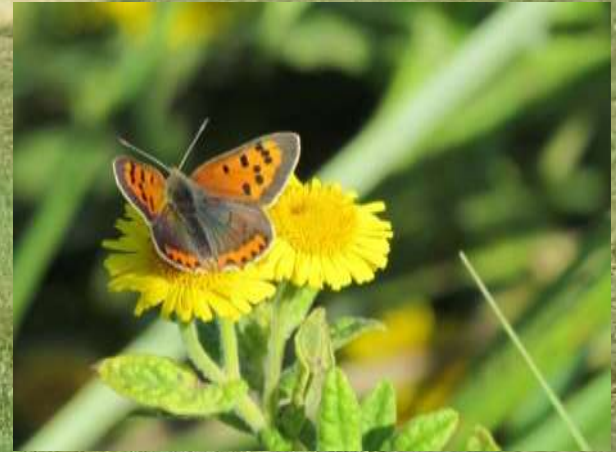
Landward slope

- south facing slopes – warm microclimate
- tussocky grass in summer
- little bare earth from rutting

Critical flood defence function in overtopping event – no scrub and short grass overwinter

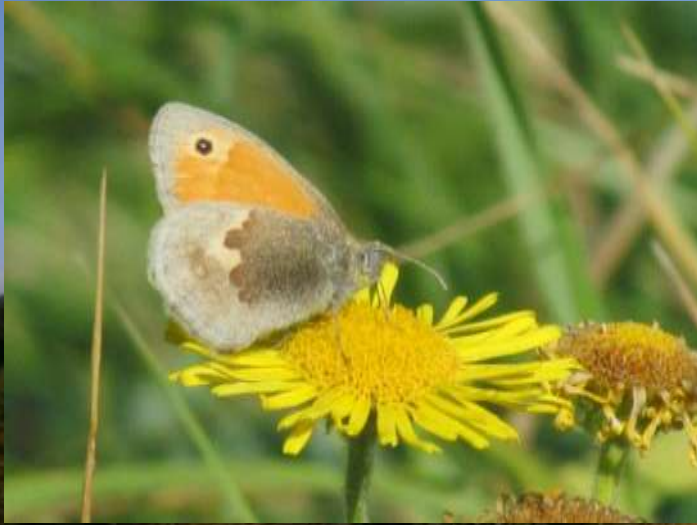
Crest

often trampled habitat and bare ground due to public footpath

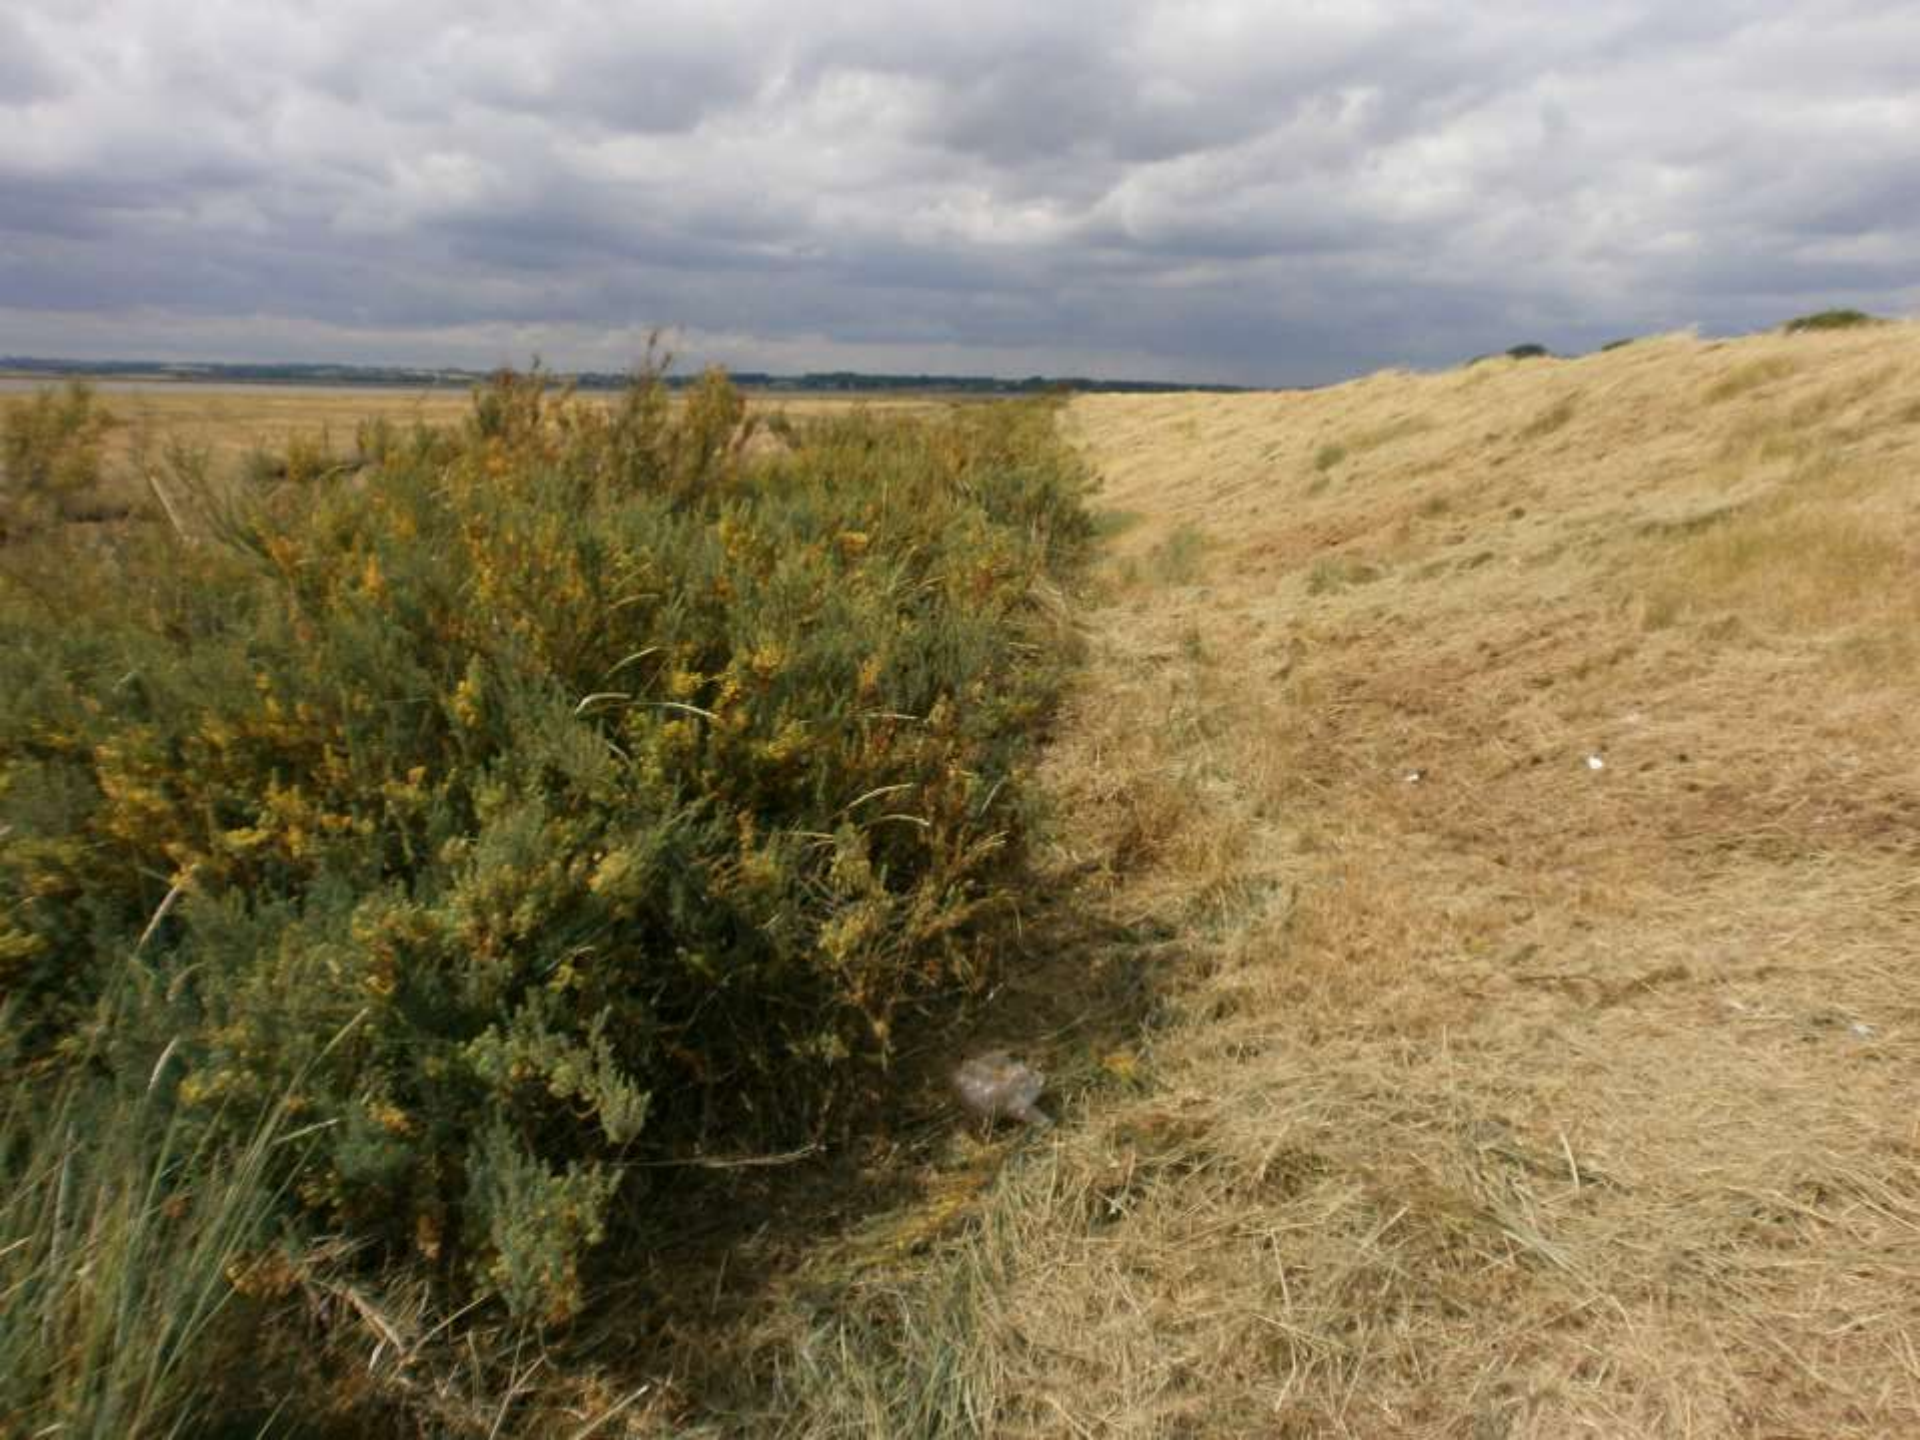
10 cm high cut

Normal cut

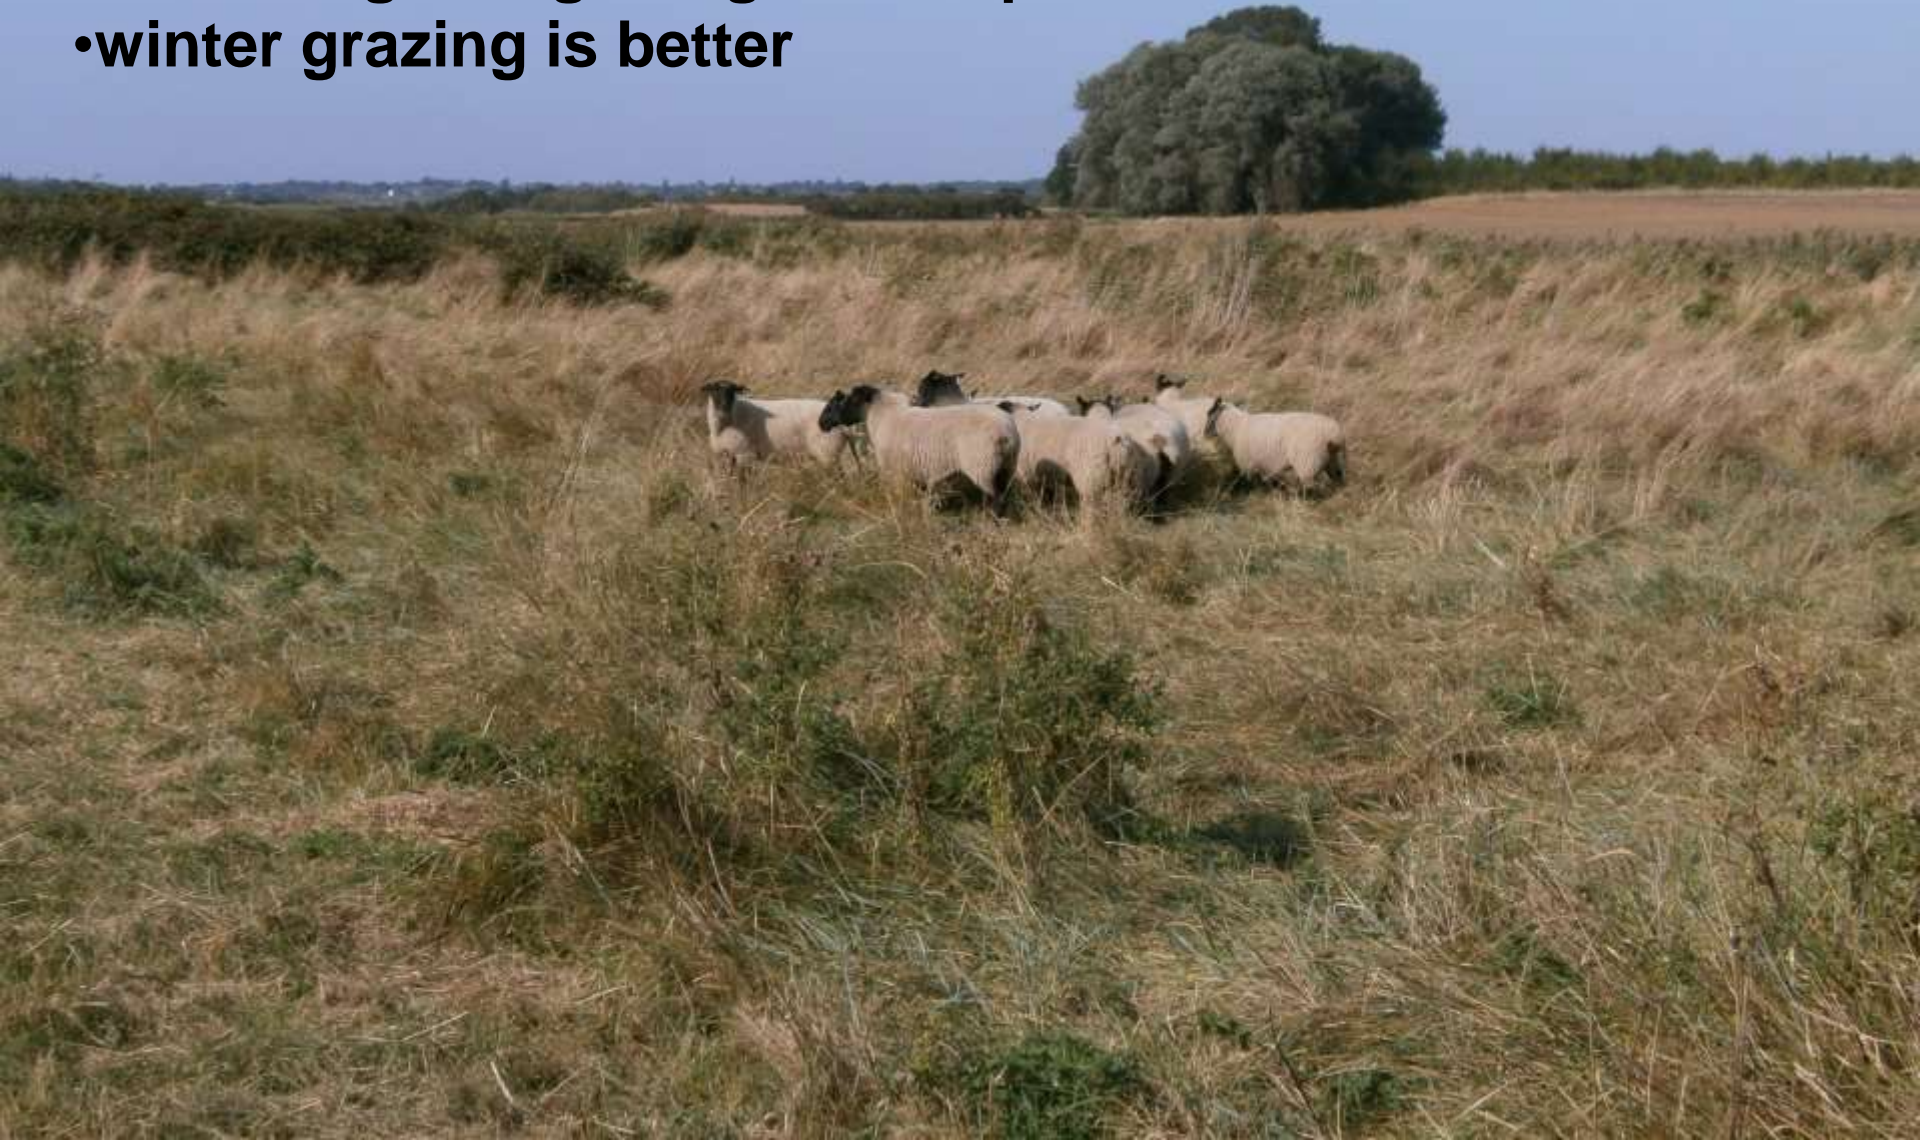
Sheep grazed

Not grazed

- where light creates sward structure
- summer grazing not good for pollinators
- winter grazing is better

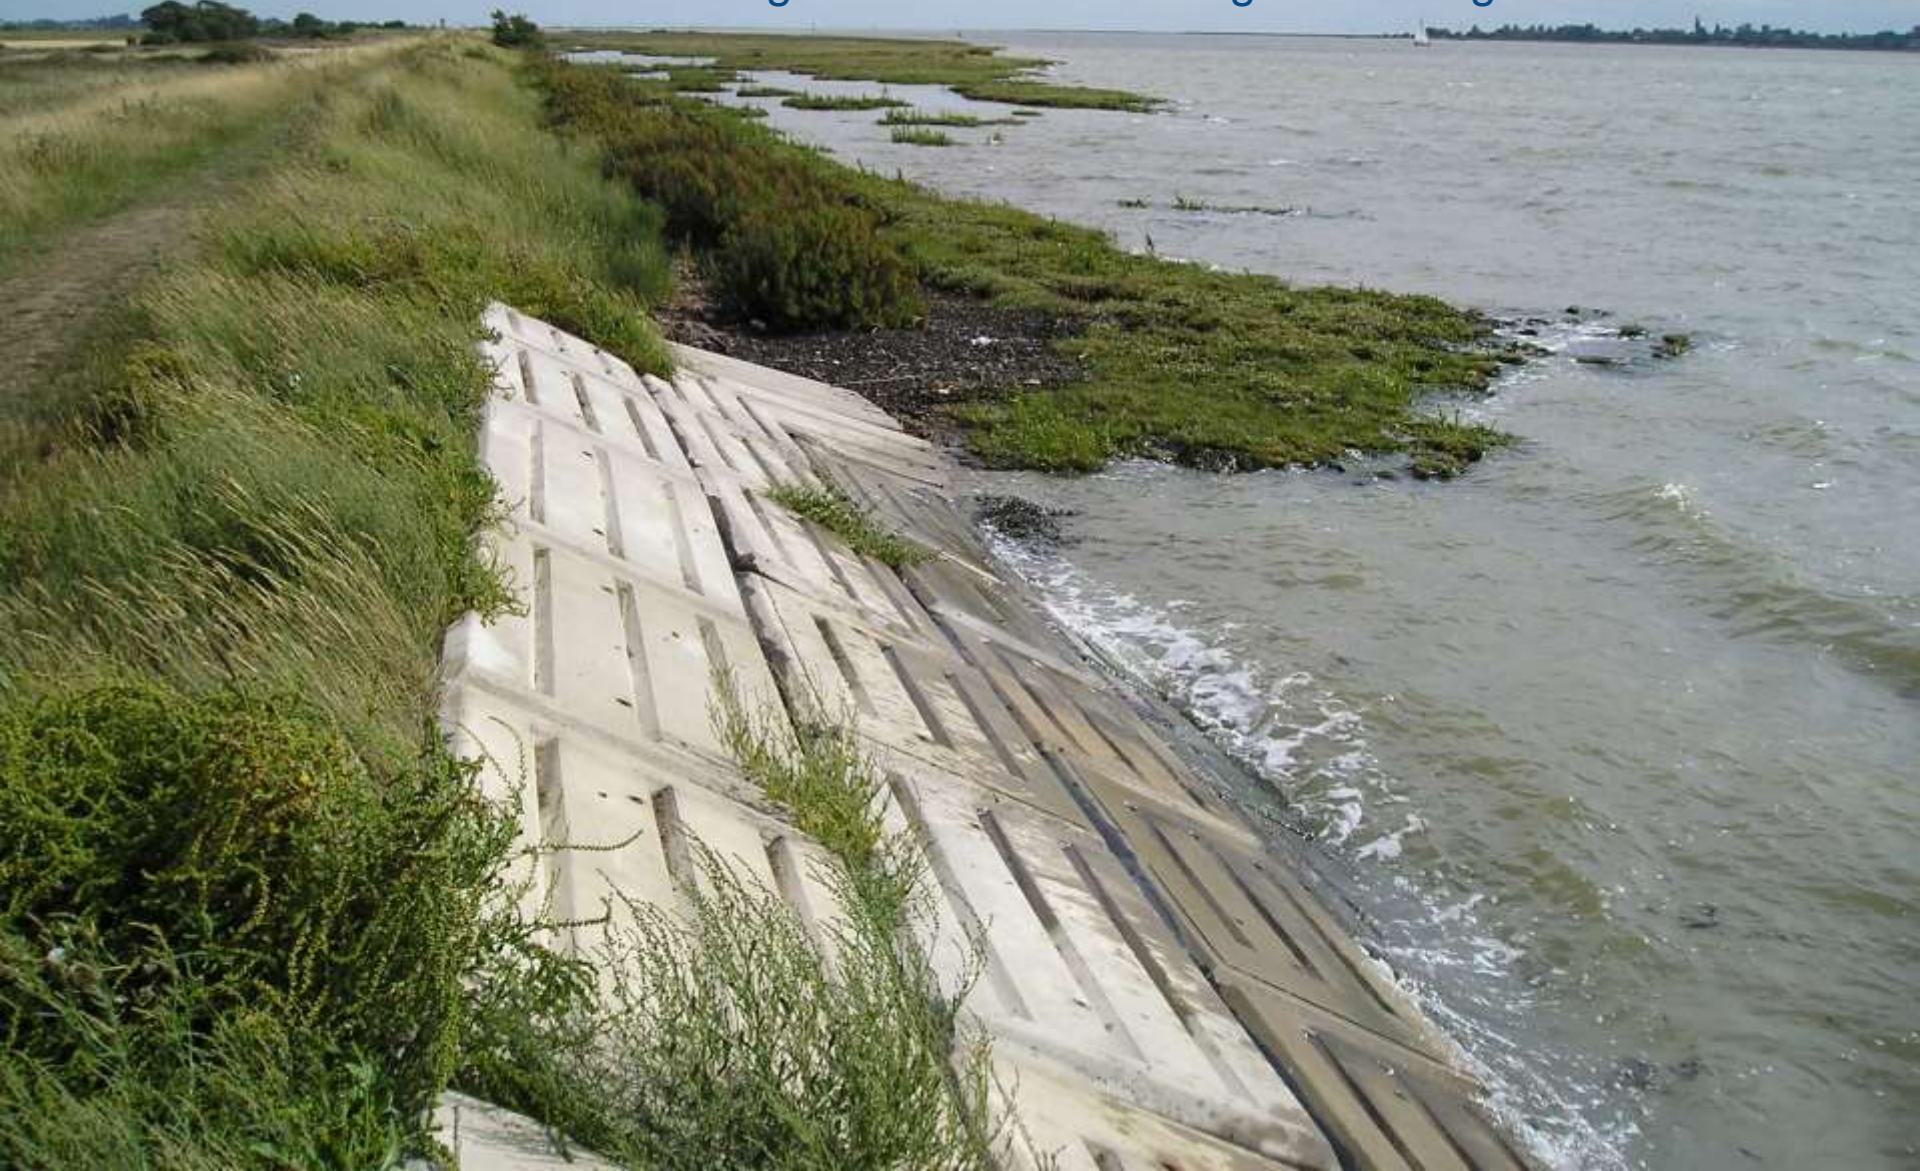
Salt marsh loss: 40 ha/year

6 m wide fringe of salt marsh can reduce costs by 70%

Wave attenuation as high as 60% even during storm surge conditions

Canewdon block replacement: £635 per m

Salt marsh terrace: £660 per m

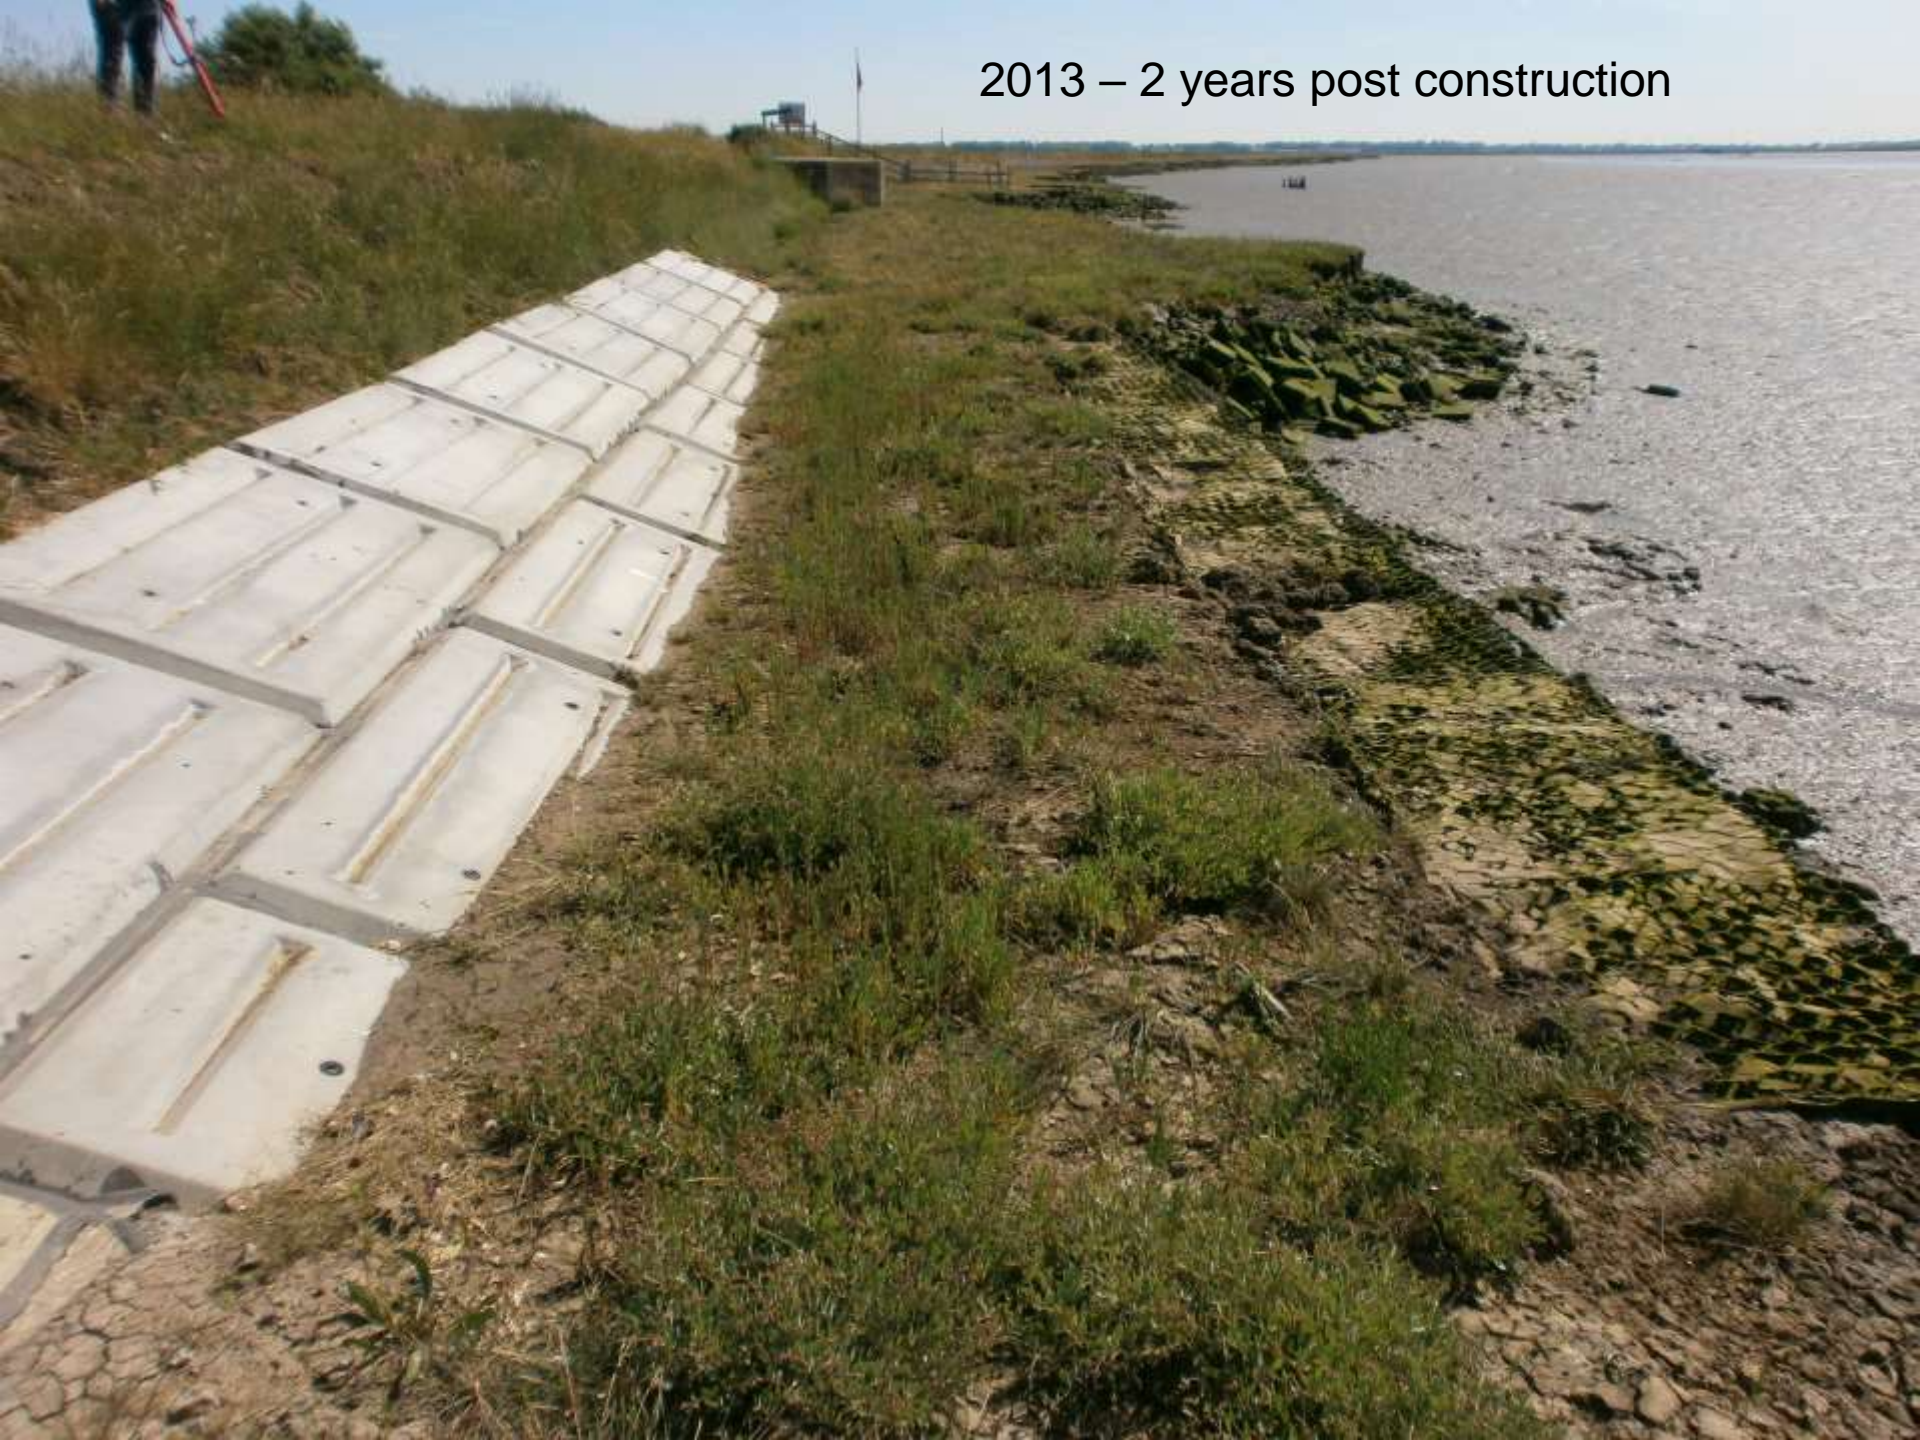
2013 – 2 years post construction

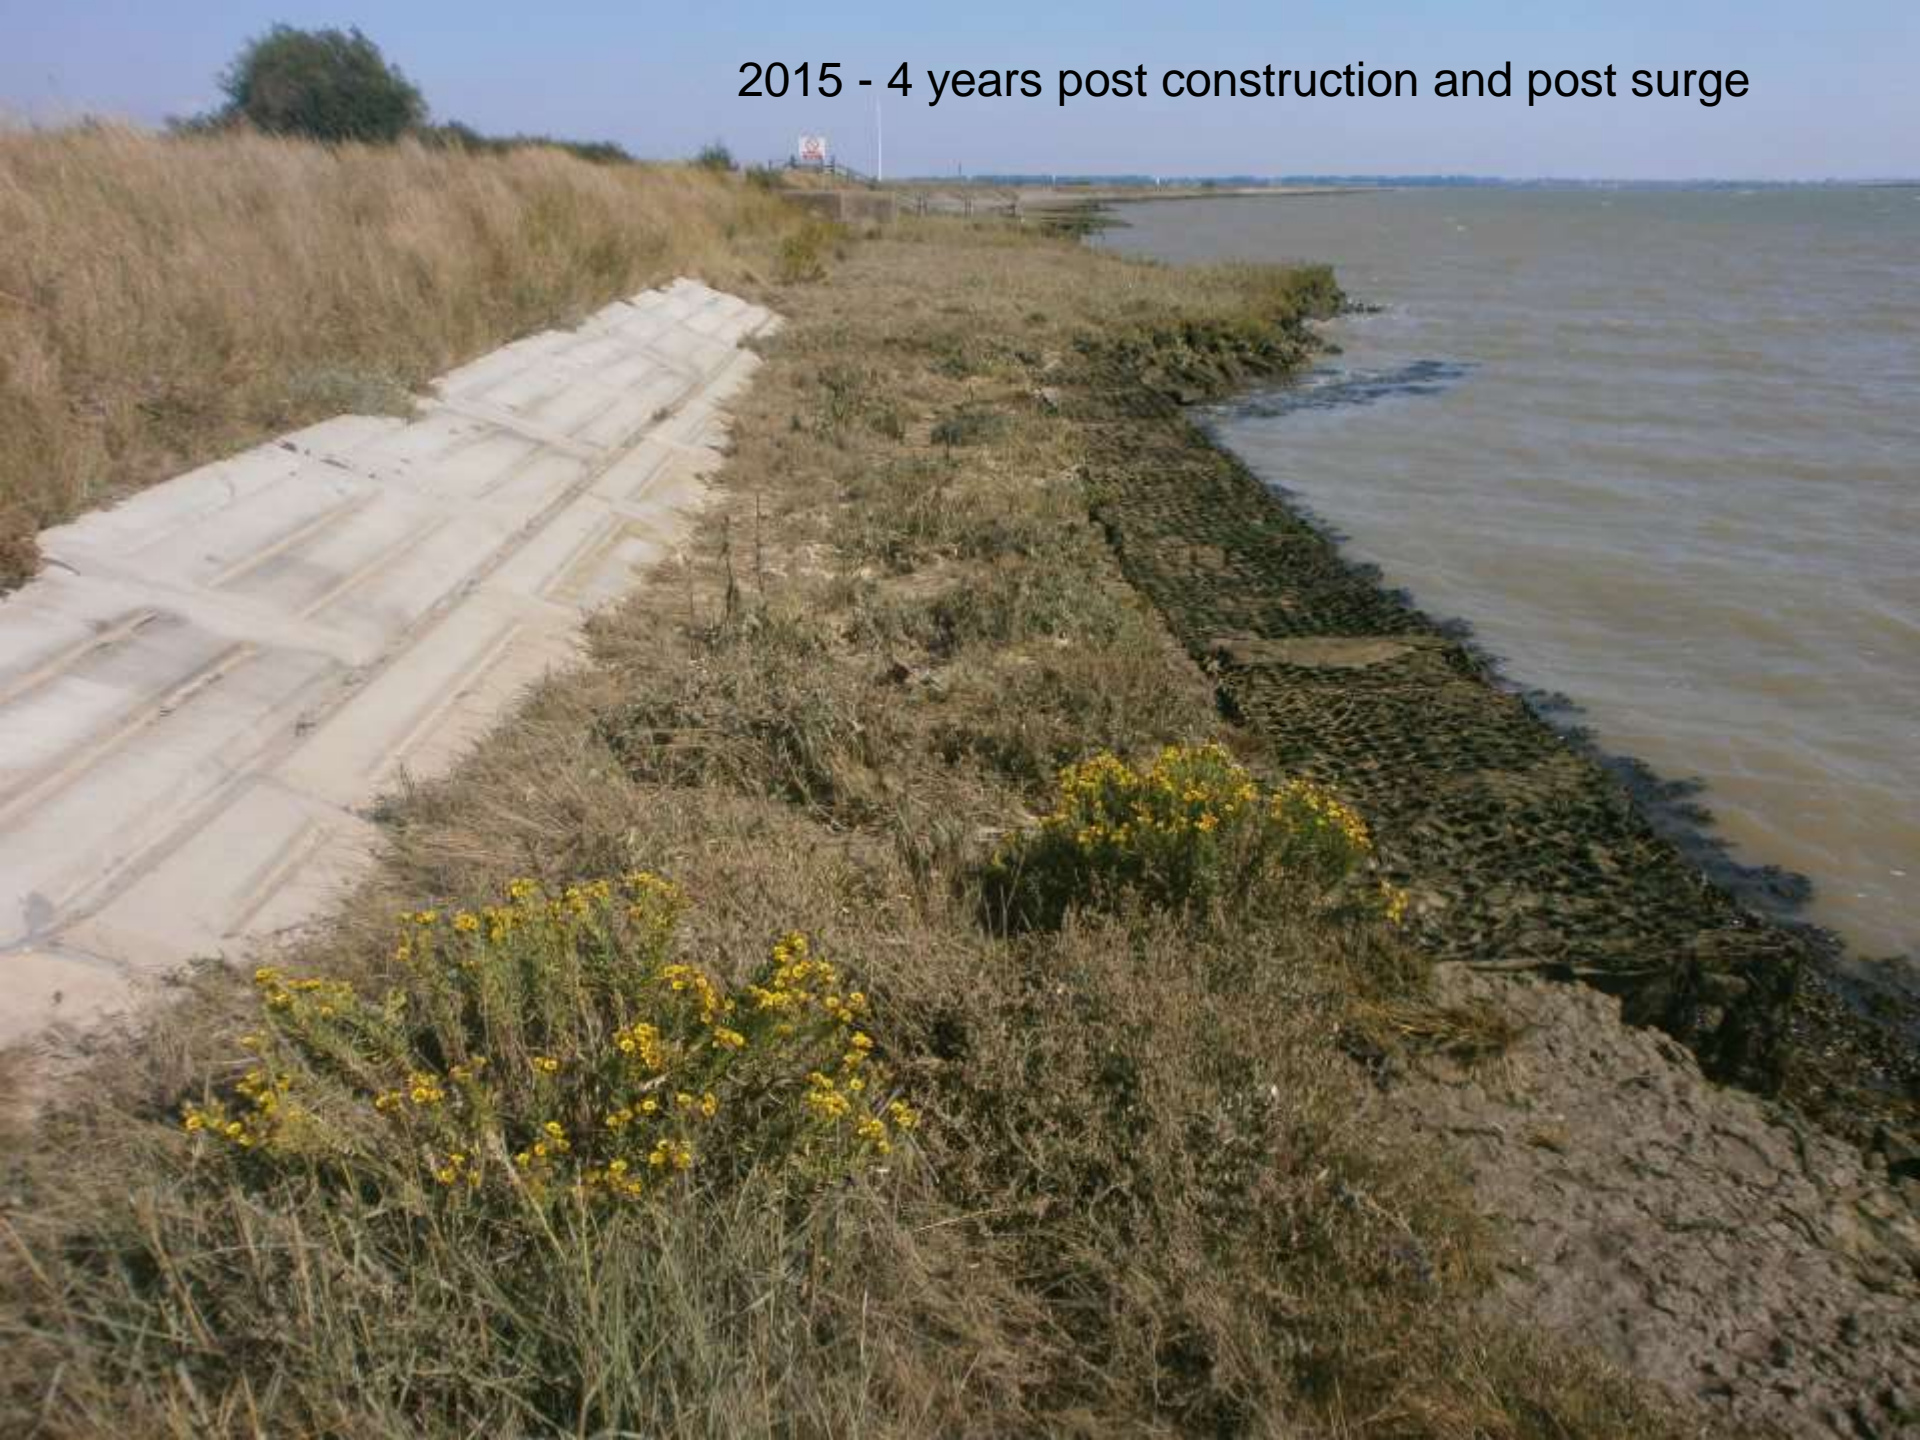
2015 - 4 years post construction and post surge

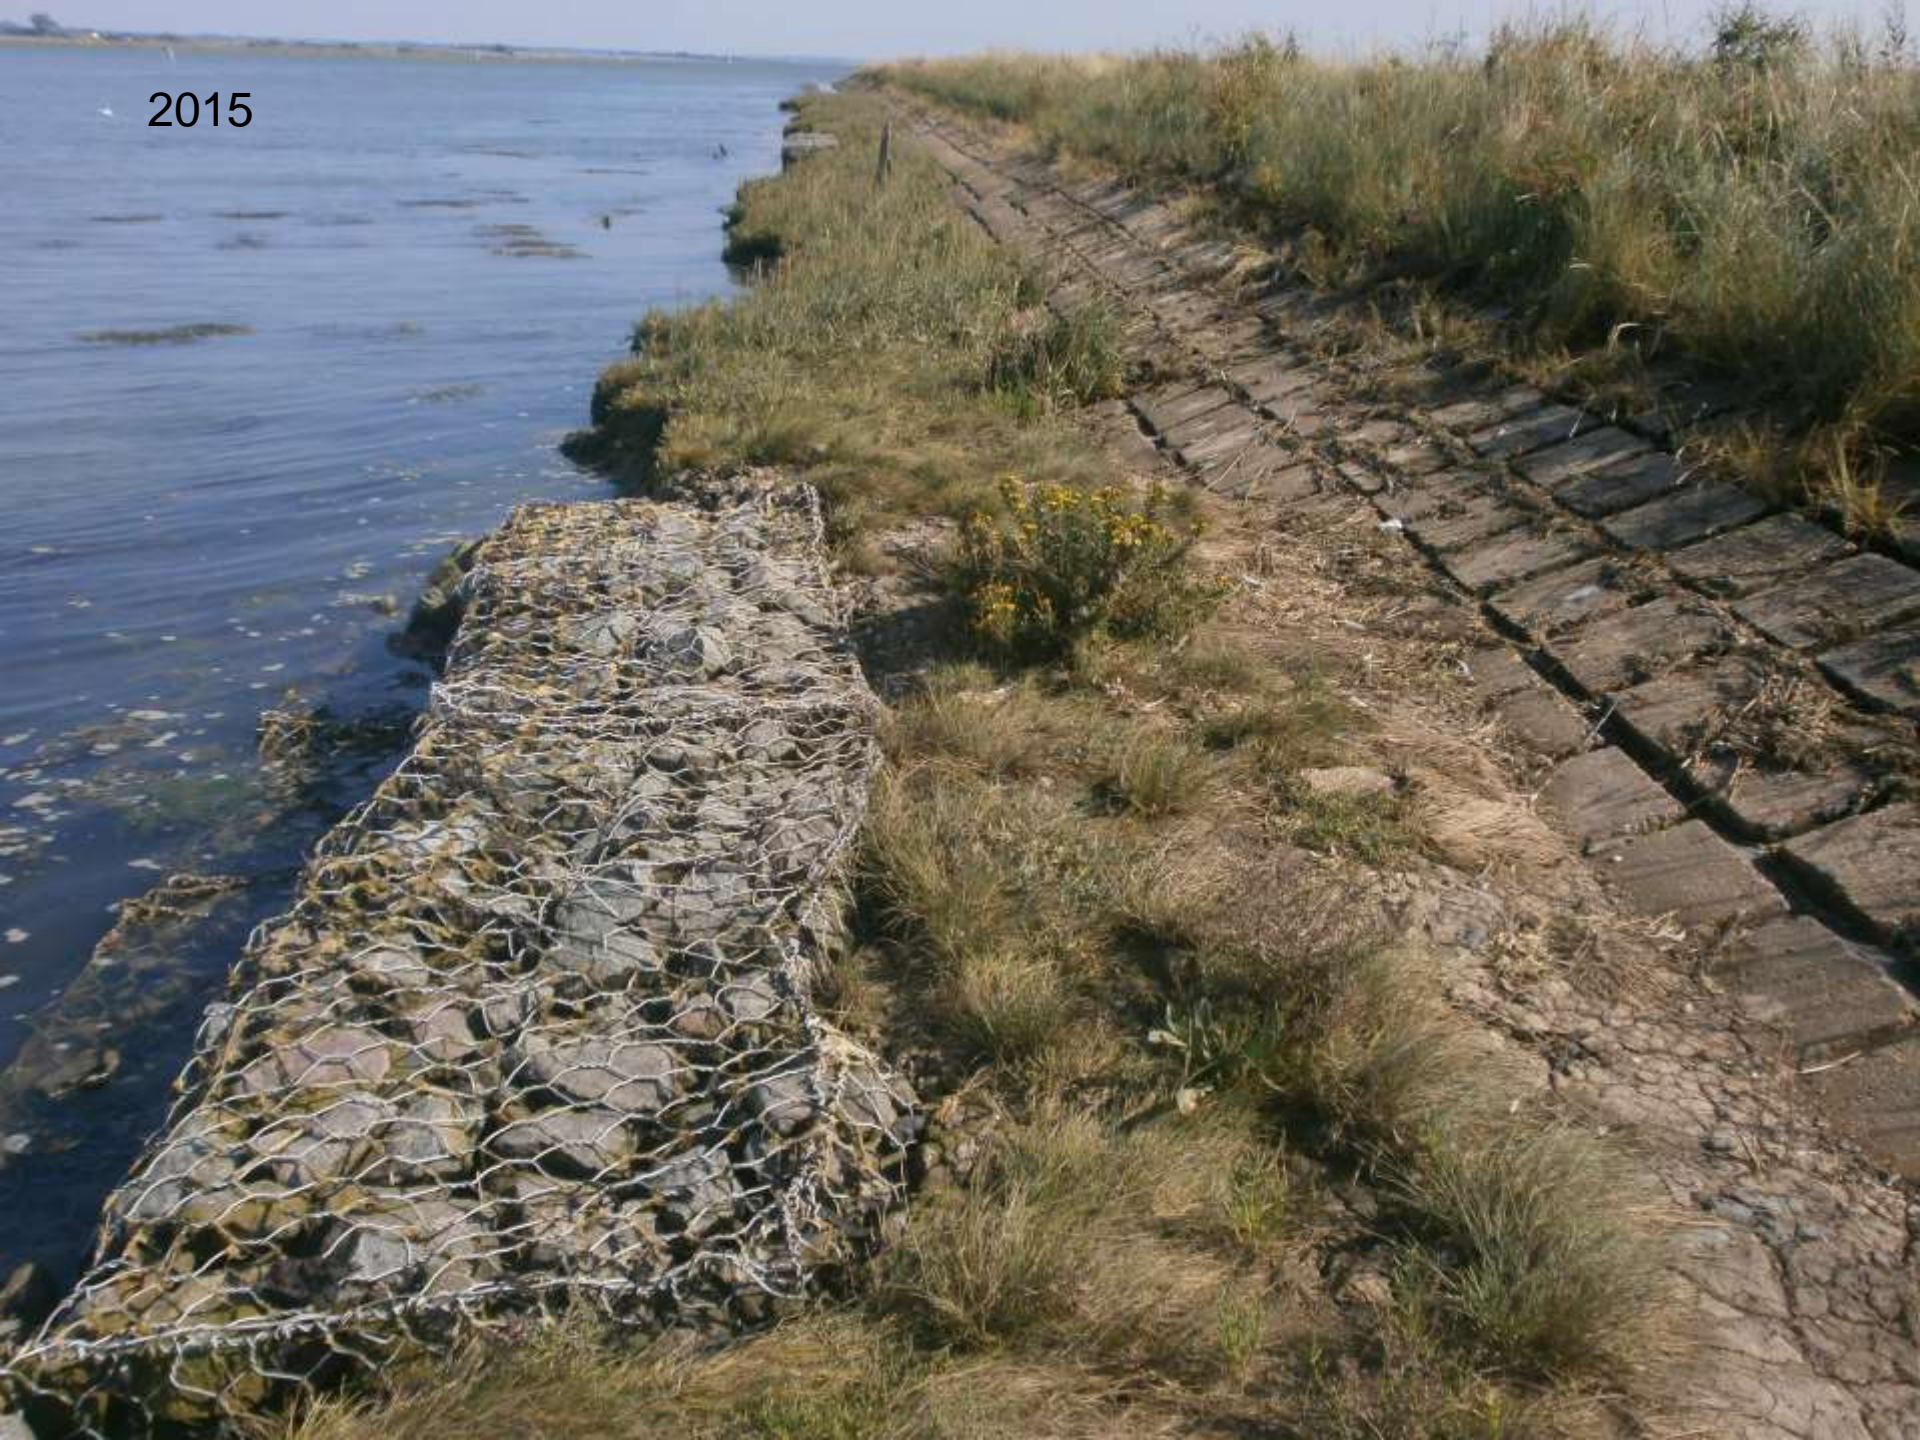
2015 – 4 years post construction and post surge

Key factors for successful colonisation:

- Elevation
- Exposure
- Proximity to existing salt marsh

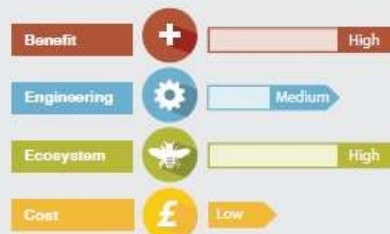
The Environment Agency took an innovative approach to an established mowing regime in an attempt to improve pollinator habitats and reduce costs. A reduced mowing regime was tested compared to business-as-usual on an earth embankment flood defence on Canvey Island. The altered mowing regime has since been implemented across 120 km of earth embankments in Essex and Kent.

The embankments are engineered flood defences, where the landward side is terrestrial grassland habitat. If managed well these assets can provide important habitat for rich bumblebee assemblages, including UK Biodiversity Action Plan species, the Shrill Carder Bee (*Bombus sylvarum*) and Brown Banded Carder Bee (*Bombus humilis*). The business-as-usual model was to routinely cut the grassland (up to four times per year) but this trial showed that by leaving the grasses and flowers uncut until at least mid-September, significant biodiversity gains can be made.

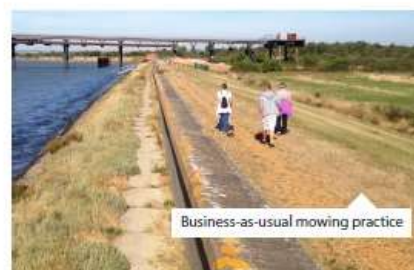
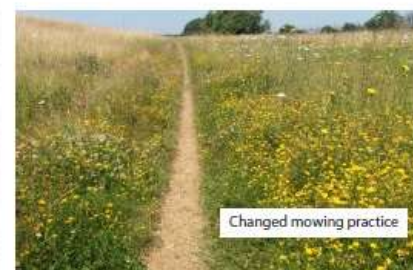
Change in management regime – altered or reduced intervention

- ➡ Over 100 km (20% of coast) in Essex of insect friendly mowing – more to come
- ➡ Working with Bumblebee Conservation Trust, MoD, RSPB, Essex Wildlife Trust and Buglife
- ➡ Seawall Biodiversity Handbook

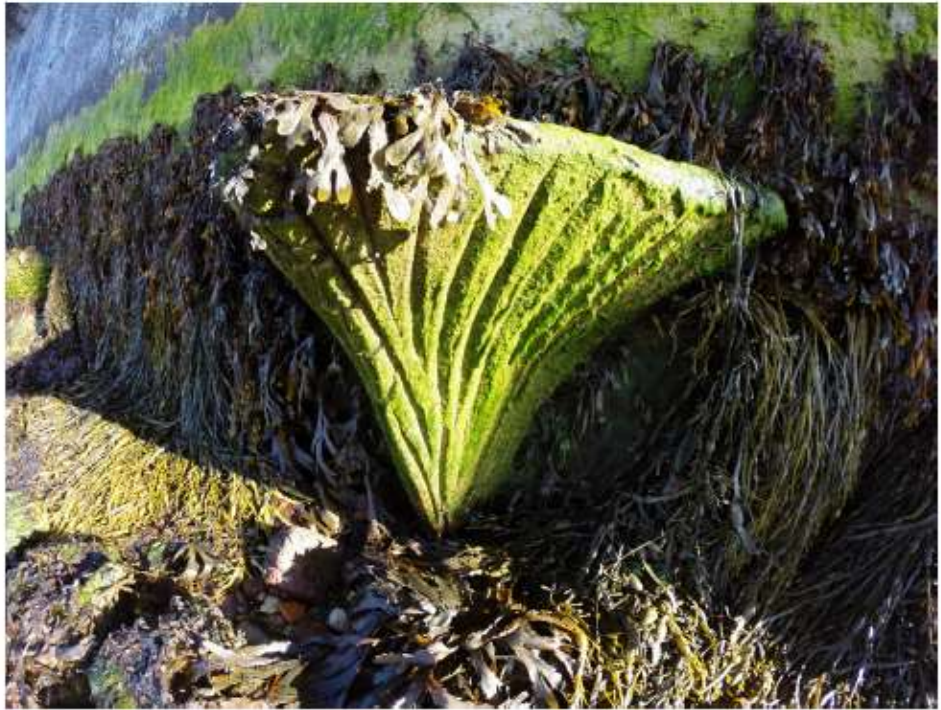
Rock pools

Artificial concrete rock pools were created on a causeway in Galway Bay, Ireland (made of precast concrete hollow-core Shepherd Hill energy dissipation (SHED) units). The water-retaining features were made by pouring quick-drying concrete around buckets in the base of the SHED units. The buckets were removed when the concrete set, leaving 10-14 cm diameter and 10-12 cm deep depressions (~1250 cm³ volume). In total, 80 pools were created: 20 in the upper (0.4 m above MHWS) and 20 in the lower (1.9 m below MHWS) shore on both the eastern (sheltered) and western (exposed) sides of the causeway.

After the initial 12 months the lower and exposed pools supported greater diversity than the upper and sheltered pools respectively. However, after 24 months, all sheltered pools became inundated with sediment, creating muddy habitats, while the lower exposed pools became colonised with greater total diversity than the upper exposed pools; showing that <20 exposed pools can improve biodiversity outcomes. For rare species, more pools would be required.

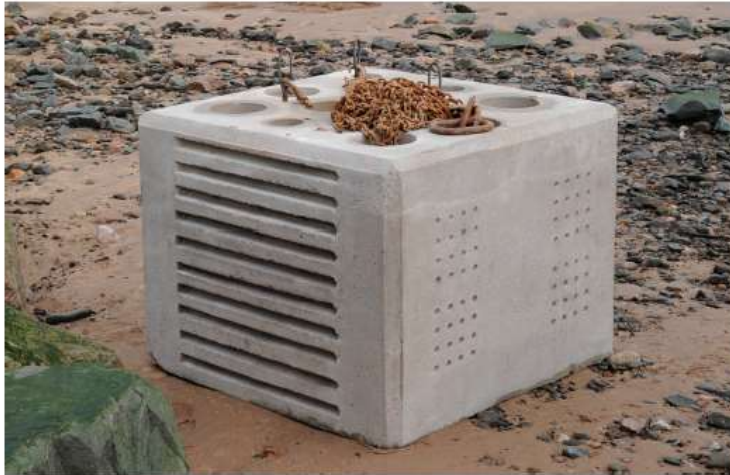
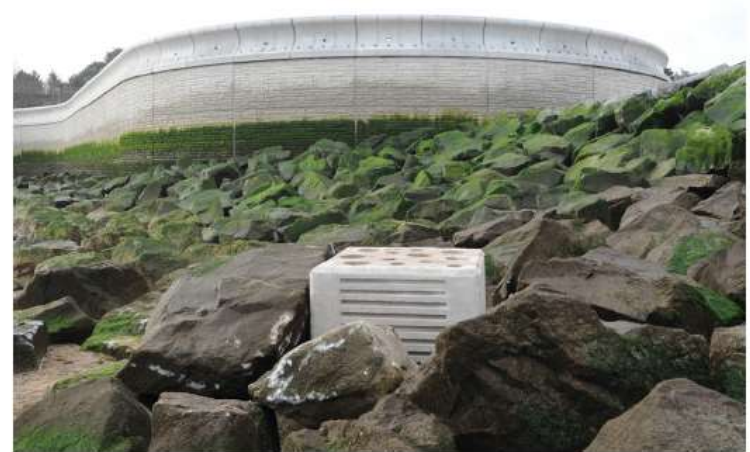
AP-C2

Precast habitat-enhancement unit comprising multiple habitat types that can be used as part of intertidal rock armour coastal defence structure. One 5.4 tonne BIOBLOCK (1.5 m × 1.5 m × 1.1 m or 2.48 m³) was deployed as part of a new rock groyne.

Expert judgement by engineers assumed no impact on engineering function of the groyne rock revetment. A BIOBLOCK can replace any rock armour unit on a defence structure and should last >10 years.

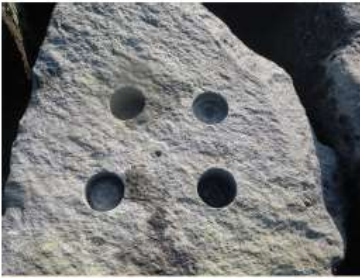
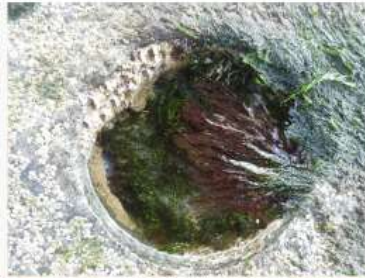
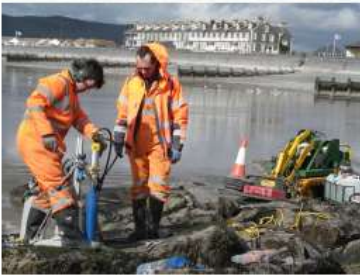
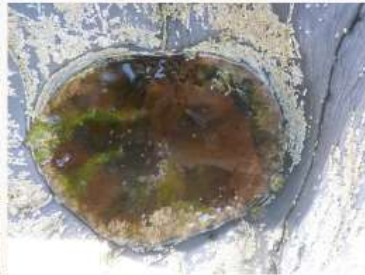
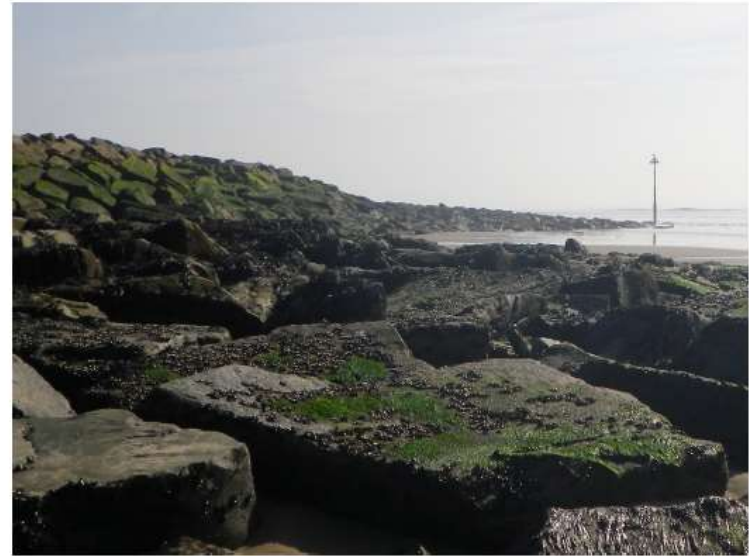
Armour drill-cored rock pools

A technique for increasing water-retaining features on horizontal or gently sloping substrates; it was tested by retrofitting sets of four 150 mm diameter holes at either 50 mm or 120 mm deep per rock armour unit using a core drill, between MLWS and MHWS, on a granite rock armoured breakwater in Tywyn, Wales.
