Greening the grey:
improving the biodiversity
value of sea wall flood
defence embankments

**Dr Tim Gardiner, Biodiversity Officer
Environment Agency**

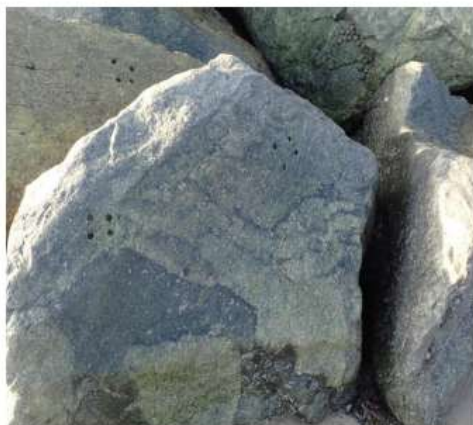
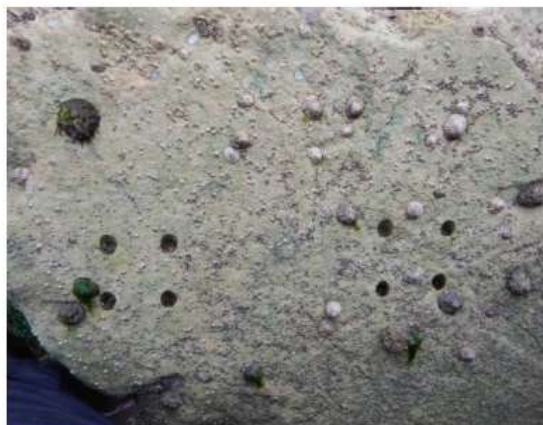
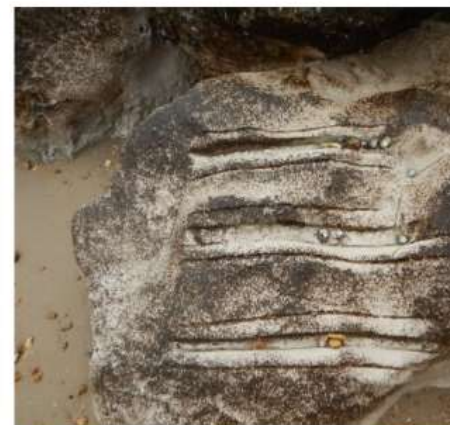
Granite and limestone rock armour were retrofitted with habitat features by drilling (arrays of 4 holes, 16 mm diameter x 20 mm deep) and scoring the rock armour with petrol saw/angle grinder (to mimic mining artefacts). Score marks were 2 mm x 600 mm x 10 mm deep above and below a central 1 mm x 600 mm long by 20 mm deep groove. The coarser middle grooves were chiselled out to create rough surface texture on the base and sides.

Both sites were monitored for 12 months where limestone had higher overall species richness and diversity than the granite rock armour. For both rock types (granite and limestone), there was a significant increase in species richness and species diversity in the holes and grooved treatments compared to the business as usual unenhanced control. The increase in species

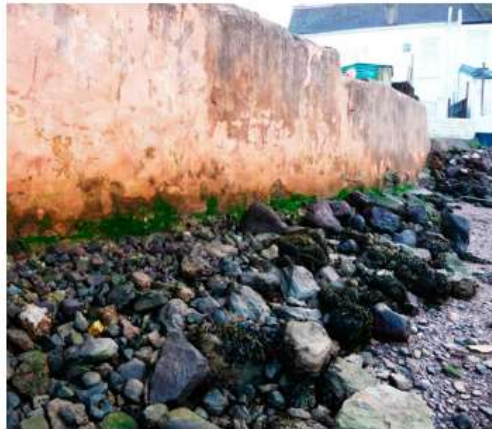
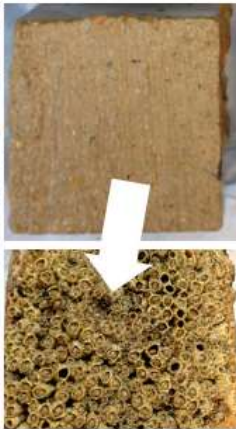
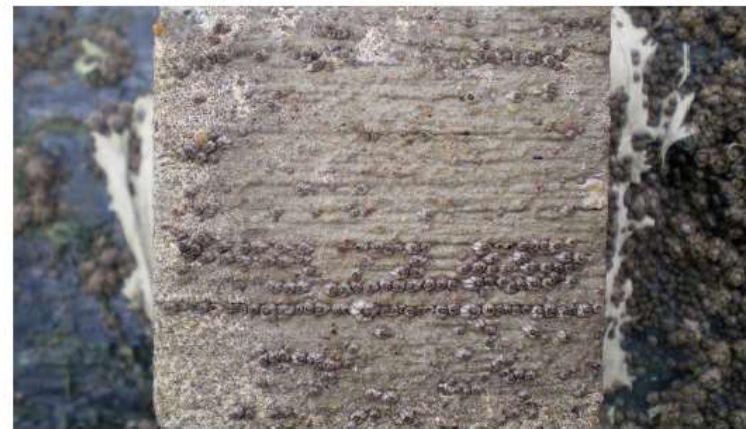
Millimetre-scale grooves applied manually using a wire brush to concrete during casting/curing designed to improve the rate of settlement and abundance of barnacles and associated species.

Only supporting ecosystem services were measured by this study. Results show that more than double the number of barnacles was found on grooved concrete than plain-cast concrete in < 6 months. Increasing barnacle abundance (via texturing) also increased invertebrate species richness (a 7:1 ratio) after 2 to 3 years.

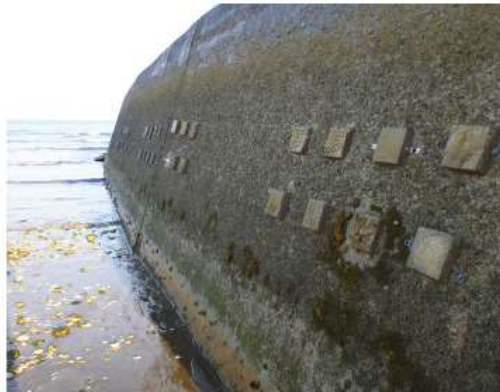
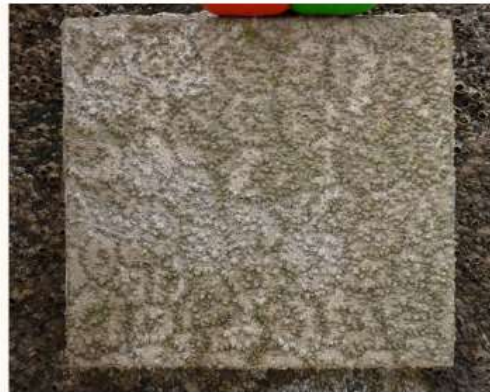
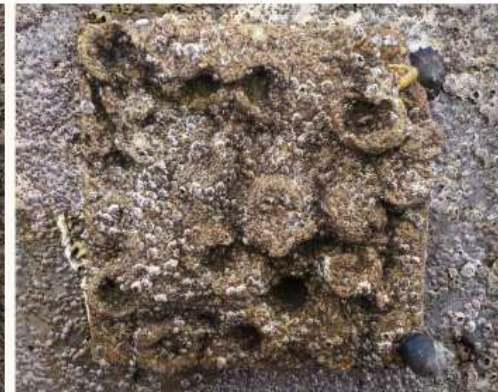
AP-C8

Textured concrete for sea walls

Testing mm to cm scale surface texture designs to ecologically enhance vertical coastal structures (e.g. defences, walls, piers, pilings) compared with industry standard smooth plain-cast concrete. Eight different tile designs (184 tiles, 150 x 150 x 40 mm) were placed at mid to upper tidal level on north facing vertical seawalls at Saltcoats harbour, Scotland (sheltered), Blackness pier, Scotland (muddy, semi-exposed estuary) and on a sea wall on the Isle of Wight, England (moderately exposed). Tiles were cast in two material types: marine concrete and natural cement-based concrete.

Many of the tile designs attracted high abundances of barnacles in as little as 6 months post-installation (over one settlement season for barnacles). High barnacle abundance has been found to reduce weathering-related deterioration in field and laboratory trials (AP-C9); there is potential to use some of these designs in future formwork to improve asset resilience.

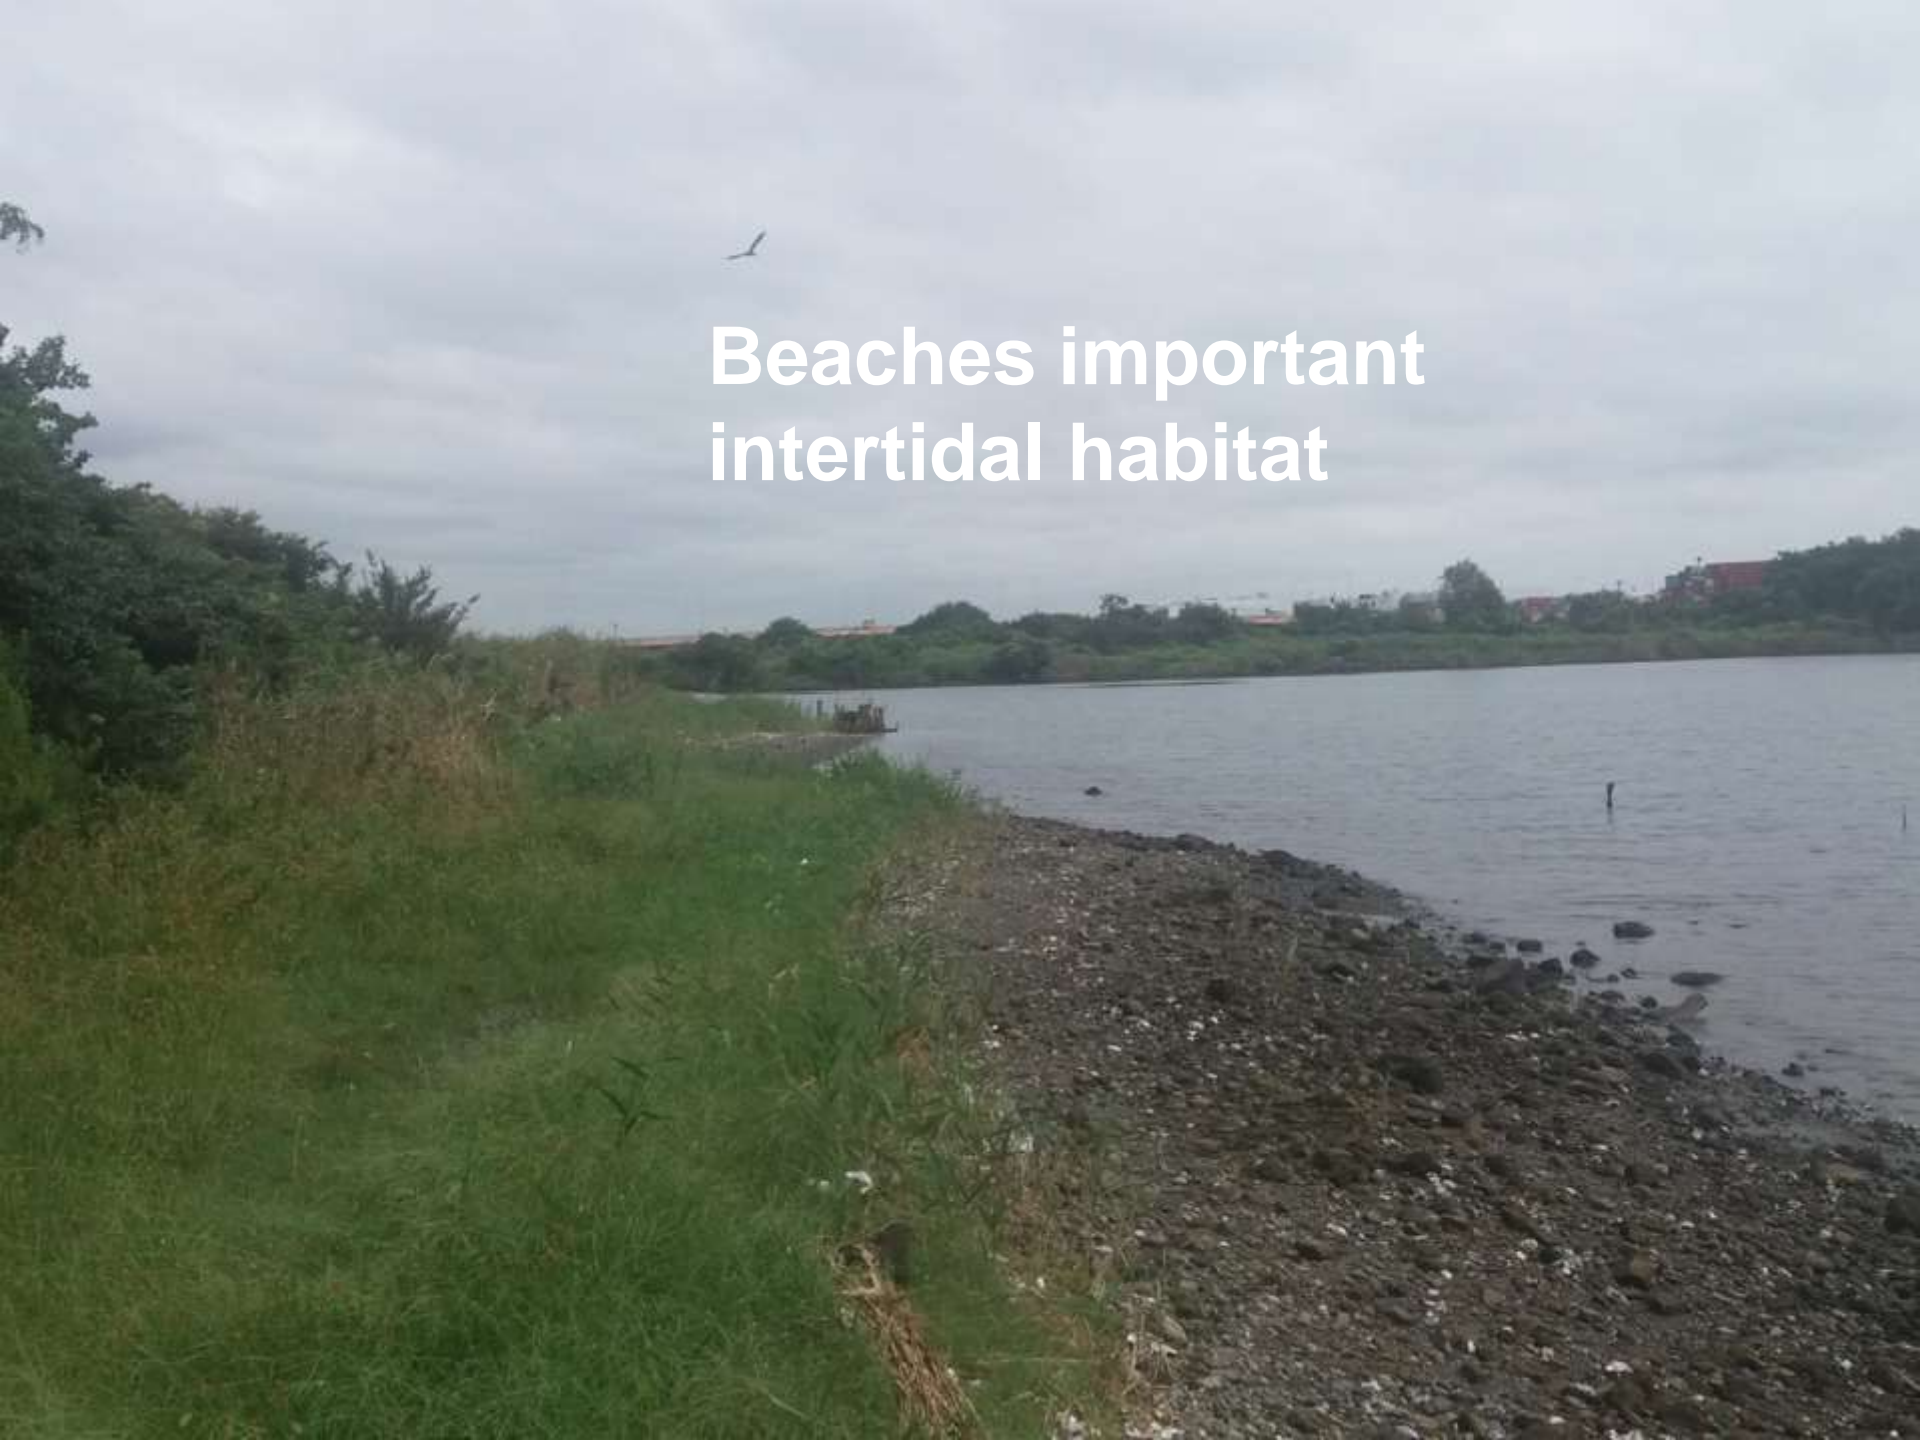
**Beaches important
intertidal habitat**
